**DESTROYER ENGINEERED OPERATING CYCLE  
(DDEOC)**

**System Maintenance Analysis**

**FF-1052 CLASS**

**BASIC POINT DEFENSE SURFACE MISSILE LAUNCHING SYSTEM  
SMA 204-7212**

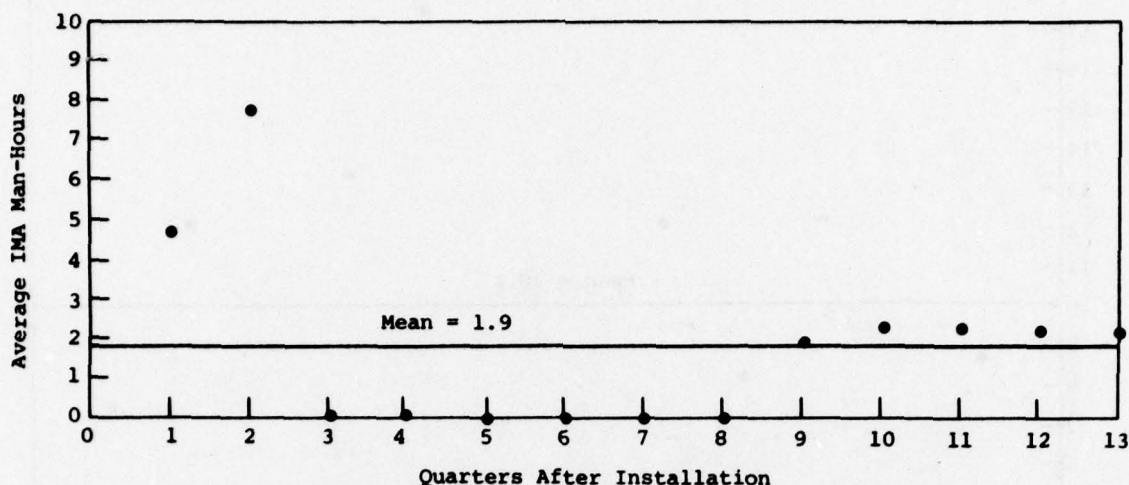
Figure 3-1. AGGREGATE LAUNCHER COMPONENT AVERAGE IMA MAN-HOURS VS QUARTERS AFTER INSTALLATION

Figure 3-1 is a plot of the average IMA man-hours reported per ship per quarter after Launching System installation. The data points for quarters 1 and 2 are inconsistent with the remaining 11 quarters. This is attributed to maintenance problems associated with initial system installation. The remaining data points do reflect a maintenance burden between 0 and 2.6 man-hours per quarter, with the mean or average burden through 13 quarters being 1.9 man-hours per quarter. This is not considered a significant burden, and there is not sufficient evidence to conclude that the IMA maintenance burden will become significant during an extended operating cycle.

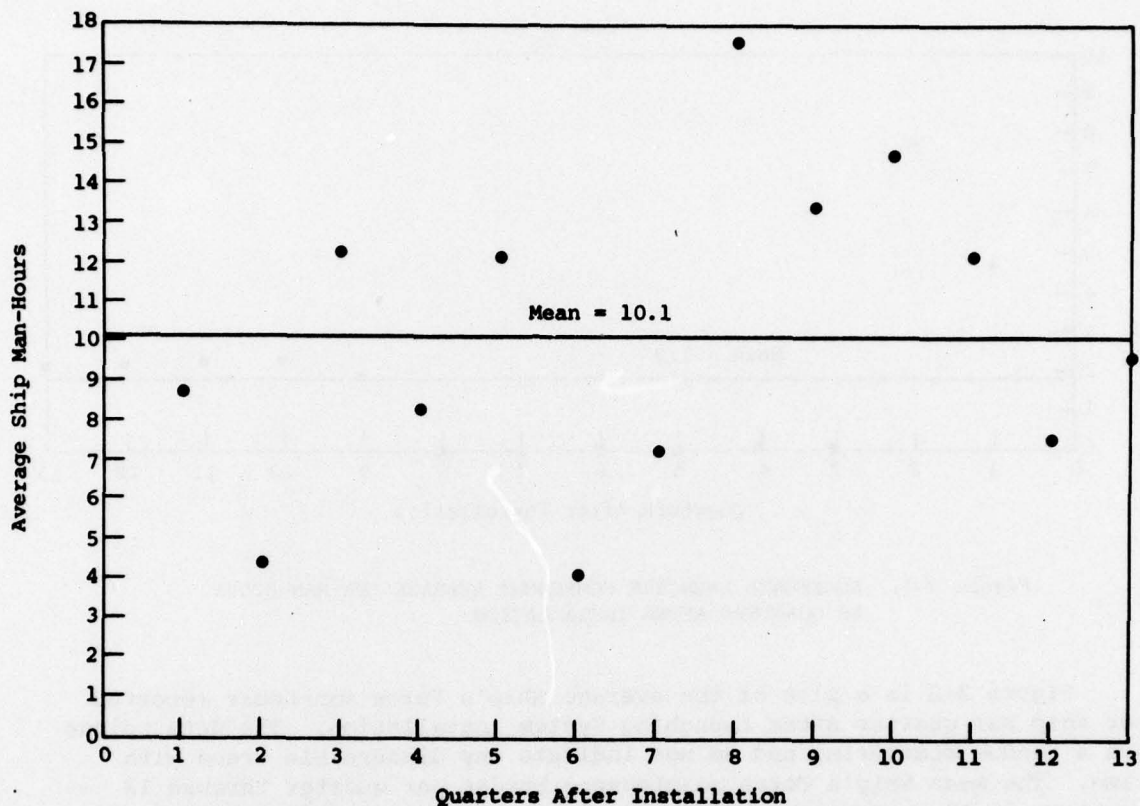
Figure 3-2. AGGREGATE LAUNCHER COMPONENT AVERAGE SHIP MAN-HOURS VS QUARTER AFTER INSTALLATION

Figure 3-2 is a plot of the average Ship's Force man-hours reported per ship per quarter after Launching System installation. The data points are a random scattering and do not indicate any discernible trend with time. The mean Ship's Force maintenance burden per quarter through 13 quarters is 10.1 man-hours, with a maximum quarterly average of 17.7 man-hours occurring in the eighth quarter. Neither the mean nor the maximum man-hour levels are considered significant quarterly burdens.
